**Los Angeles County Fire Department**  
**Lifeguard Headquarters**  
2300 Ocean Front Walk, Venice, CA 90291

**Building Assessment Report**  
Architectural, Structural, Mechanical, & Electrical

Prepared for:  
**County of Los Angeles**  
Internal Services Department

30 June 2014

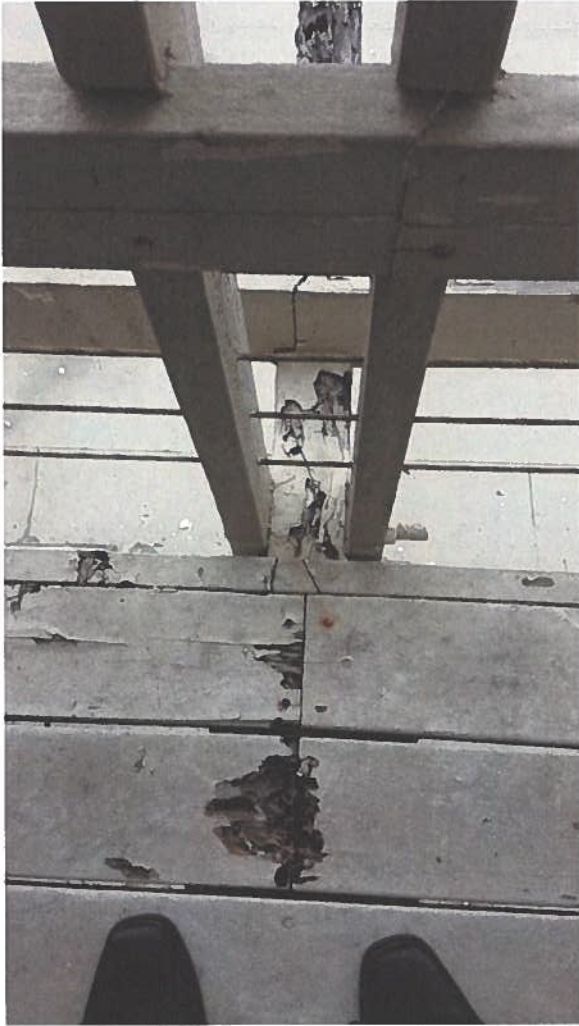
Balcony Deck & Beam outrigger dry-rot

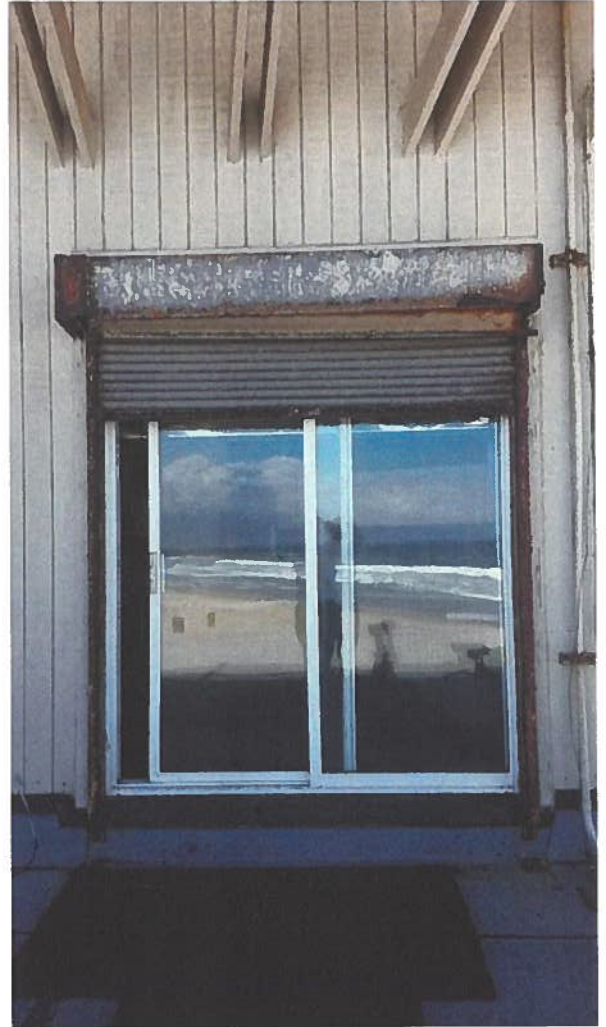
2<sup>nd</sup> level rusted metal roll-up door shutter

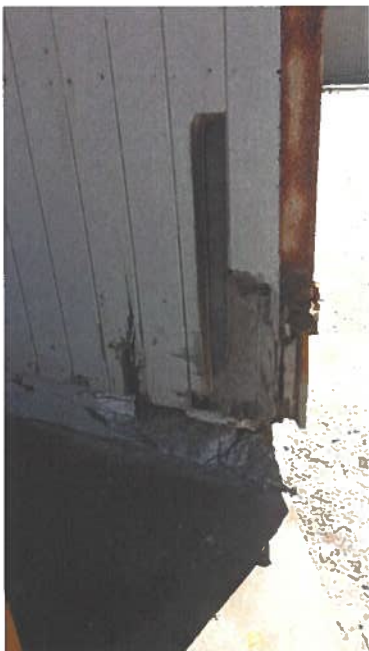
Condition at building corner

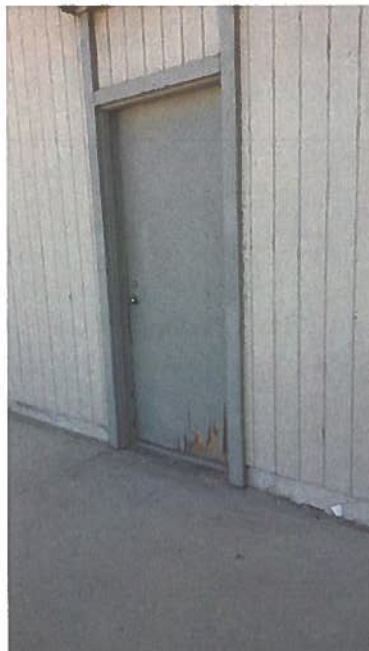
Condition at exterior door

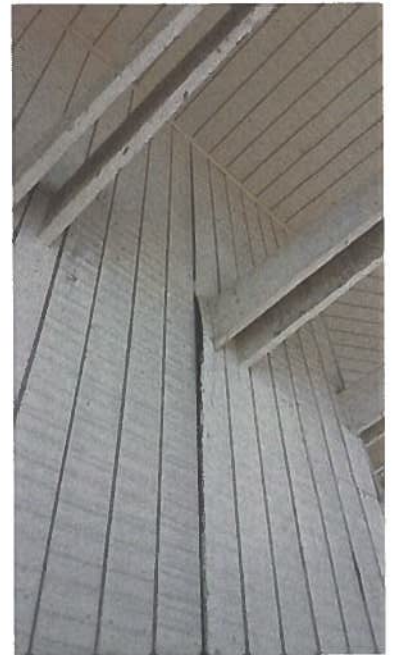
Condition at 2<sup>nd</sup> level wood siding

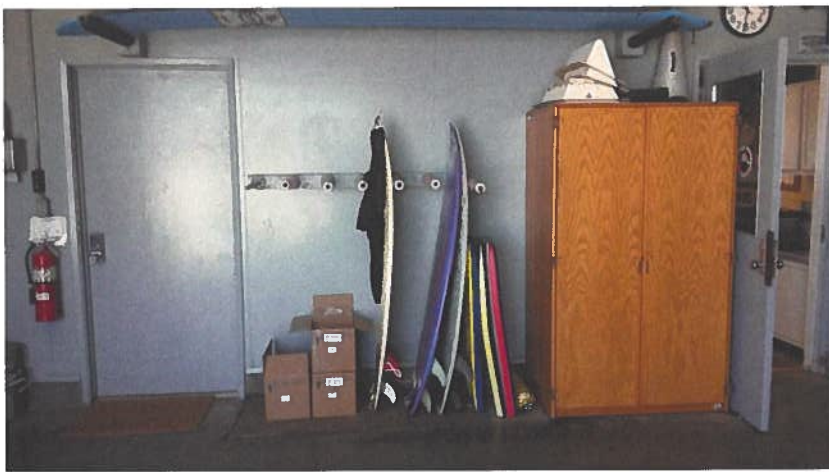
Toilet room facility-no accessible signage or accessible door hardware

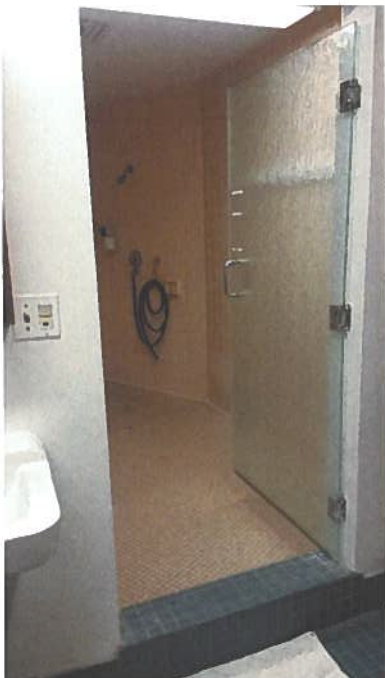
Non-conforming threshold

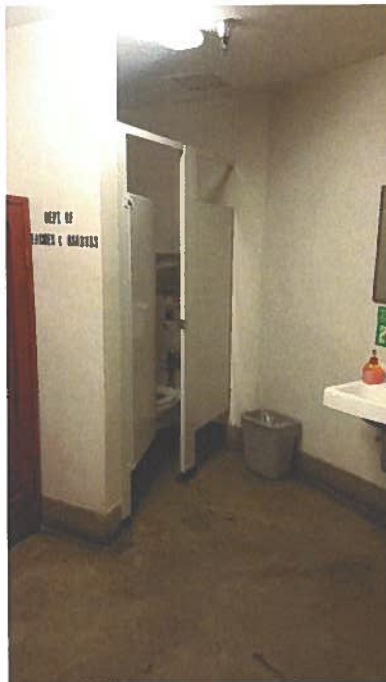
non-conforming toilet room design

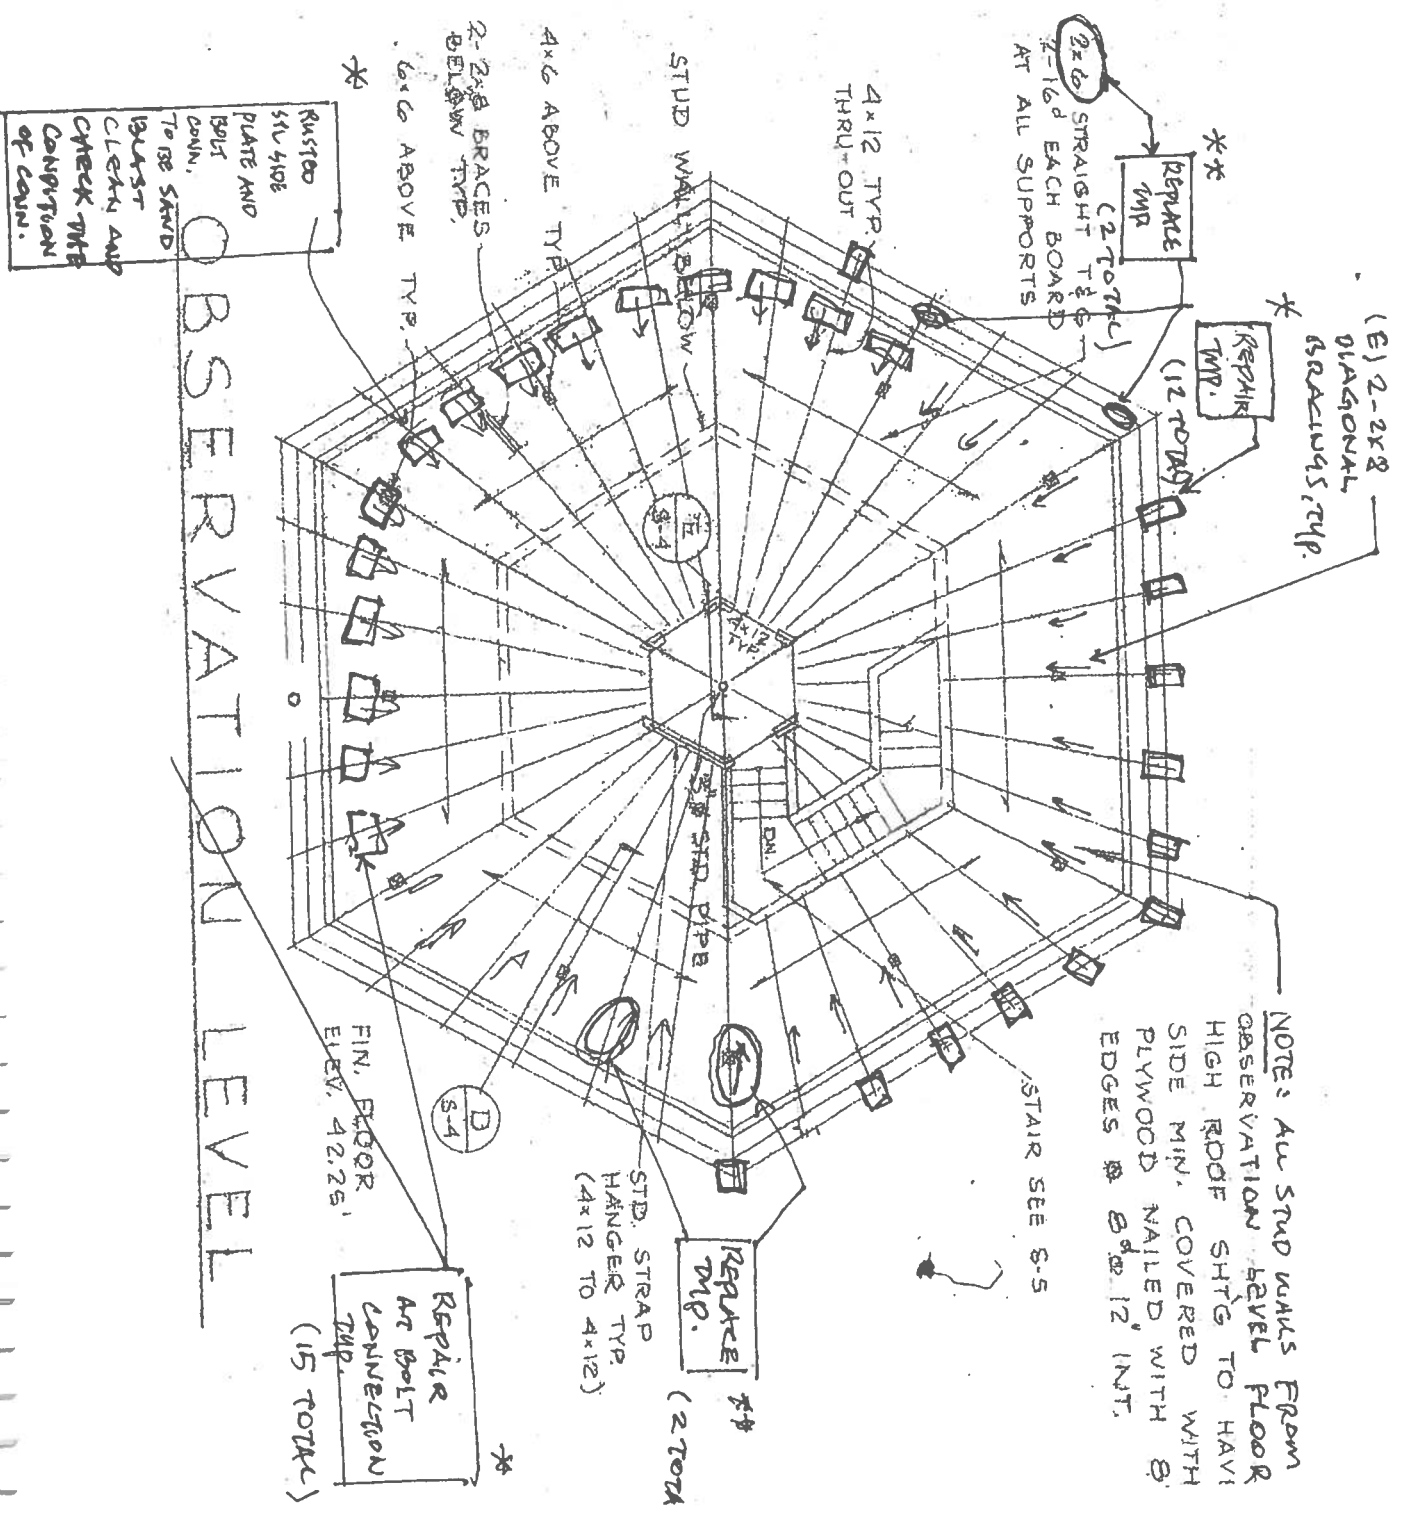
There are dry rot found at (18) 4x12 beams and rust on ¼” steel plates with (4) 1” diameter thru bolts.

See As-Built observation level floor framing plan with indication of the location that needs repair on page 4. Also, see attached photos #1, #2, #3, #4, #5, #6, #8, #11, #12 and #15.

At the observation for floor framings, propose to use ‘the total wood restoration system (see attached from pages 6 to 13), which are attached for reference to repair (E) 4x12 beams for the (E) ¼” steel side plates and (E) (4) 1” diameter thru bolt, propose to sand blast side plate and replace bolts which are rusted. Apply rust-proof coating into ¼” steel side plate after the connections have been cleaned. The estimated cost of proposed short term repair including floor framings with restoration and high roof framings with replace roof beams is \$150,000.00.

At the observation for floor framings, **replace (E) 4x12 beams with (N) 4x12 D.F.L. No.1 and better, also install impel rod for each (N) 4x12 beam to prevent future dry rot. Replace ¼” side plates and (4) 1” diameter thru bolts at bracings connection with S.S. plates and S. S. bolts.**

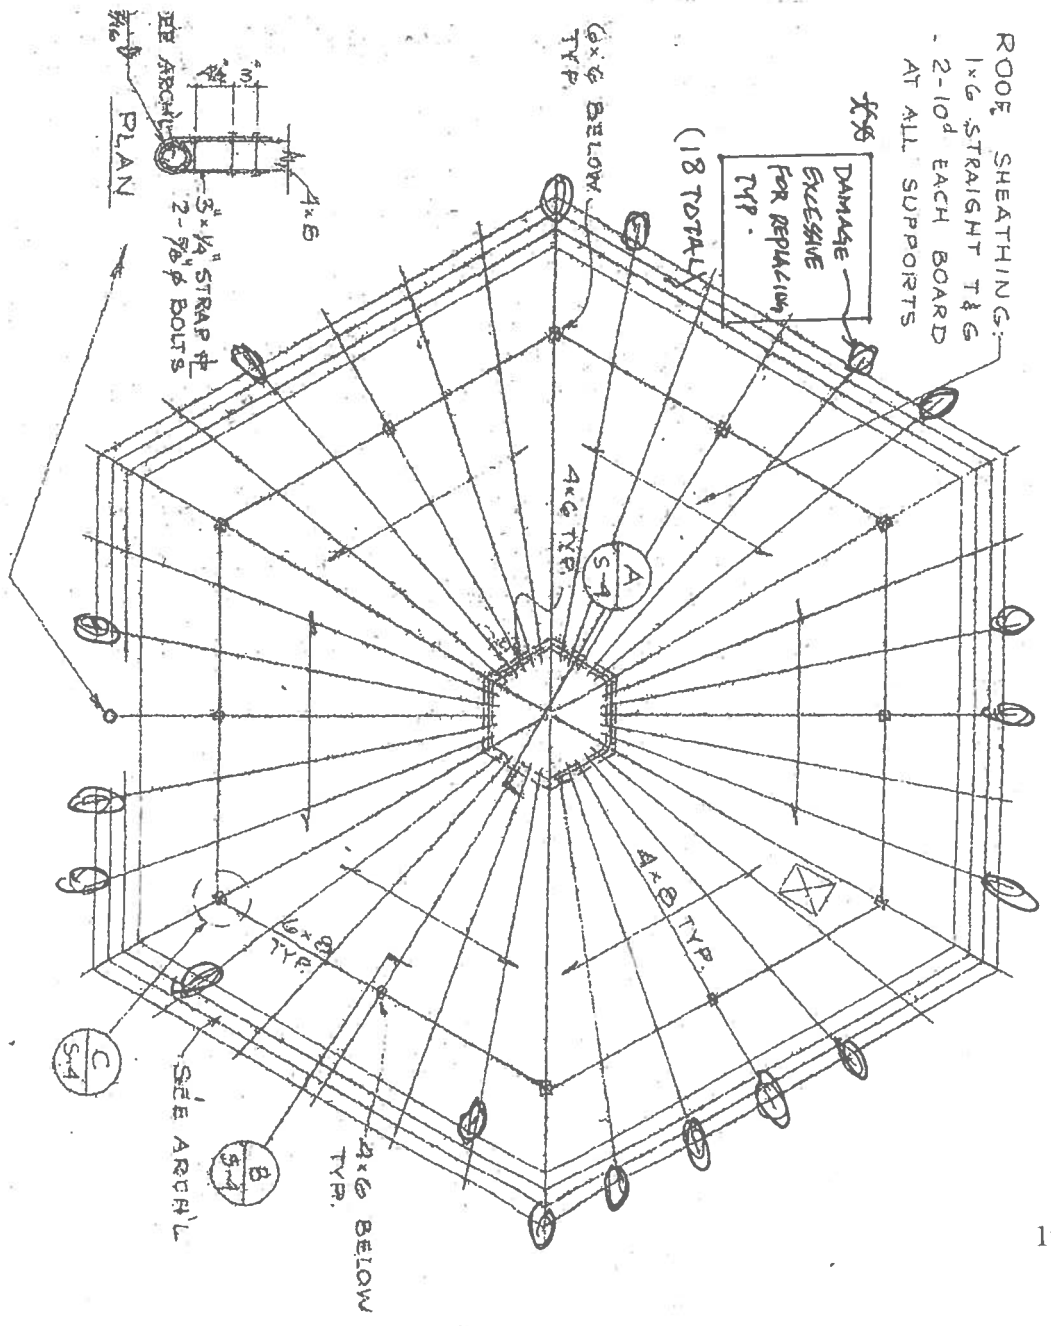
HIGH ROOF FRAMING PLAN

Standing on the (E) observation floor level, observed (E) 4x8 roof joist, (E) 6x8 roof beams and (E) 4x6 posts. All (E) 6x roof beams and (E) 4x posts are not showing any structural deficiency. **There is no structural restrengthening required, but there are dry rot found for (18) (E) 4x6 beams.**

See As-Built high roof framing plan with indication of the location that needs repair on page 5. Also, see attached photos #7, #9, #10, #13 and #14.

At high roof framings, propose to replace (E) 4x8 beams with (N) 4x8 D.F.L. No.1 and better, also install impel rod for each (N) 4x8 beam to prevent future dry rot.

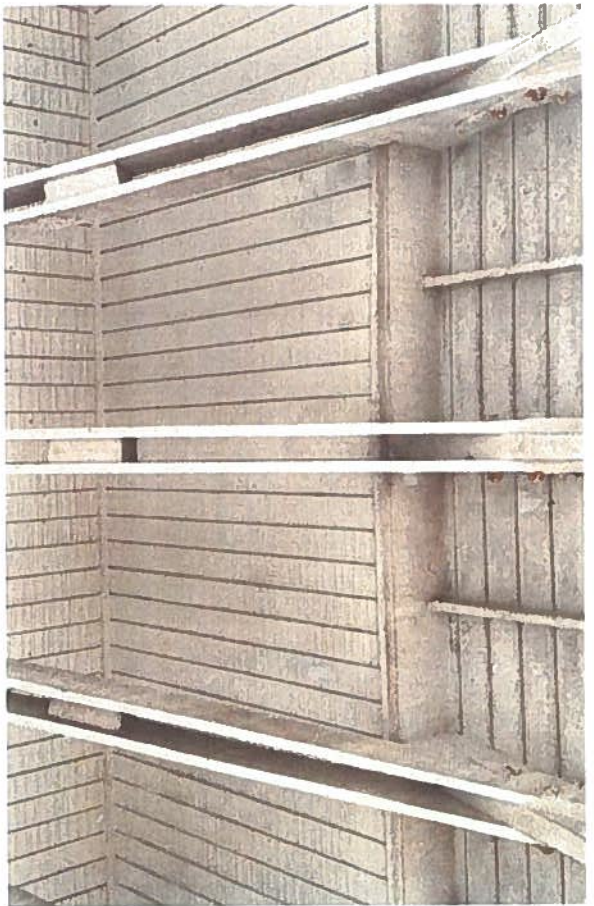
PHOTO #1

(E) 2-2X BRACING AT OBSERVATION LEVEL)

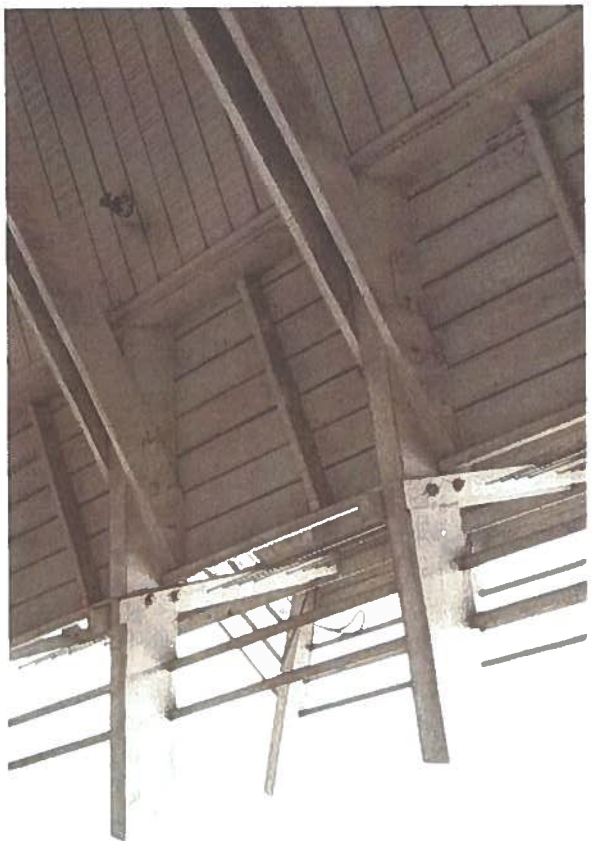
PHOTO #2

(E) 2-2X BRACING / (E) 4X BEAM)

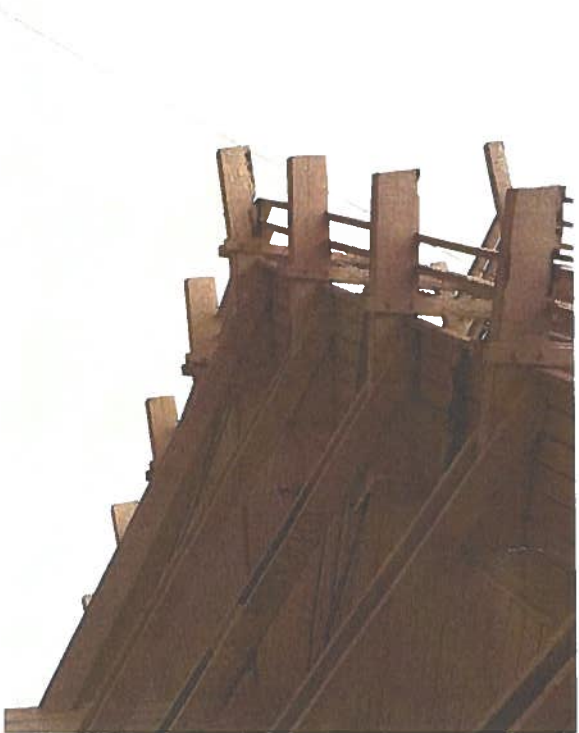
PHOTO #3

(E) 2-2X BRACING / (E) 4X BEAM)

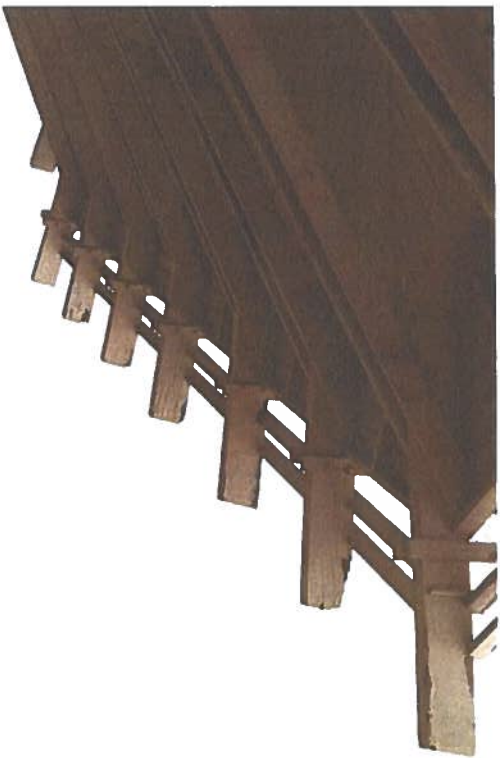
PHOTO #4

(E) 2-2X BRACING / (E) 4X BEAM)

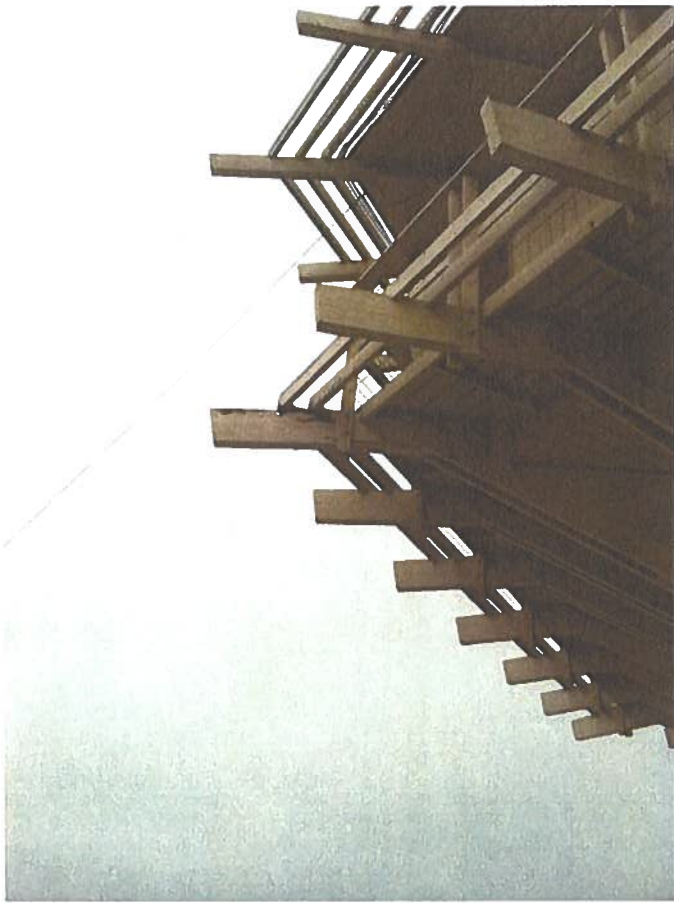
PHOTO #5

(E) OBSERVATION LEVEL AND  
(E) HIGH ROOF LEVEL

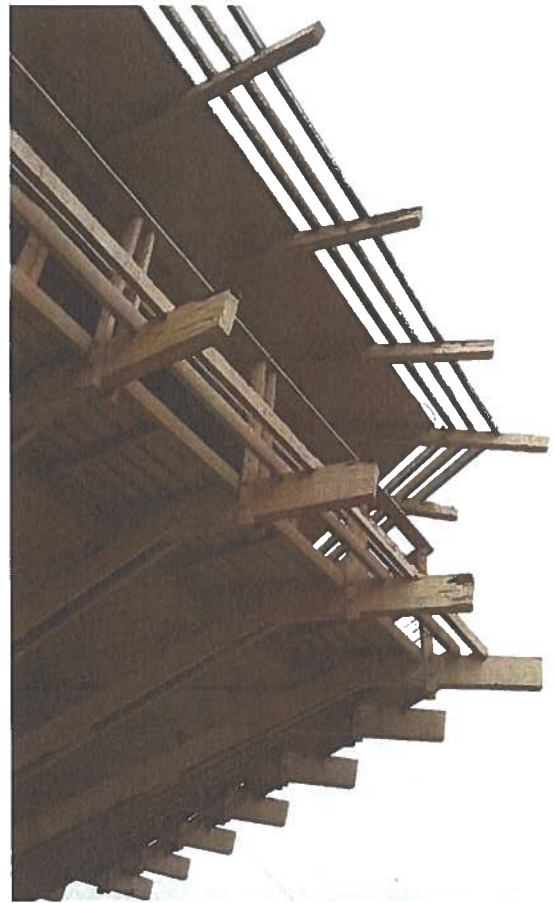
PHOTO #6

(E) OBSERVATION LEVEL AND  
(E) HIGH ROOF LEVEL

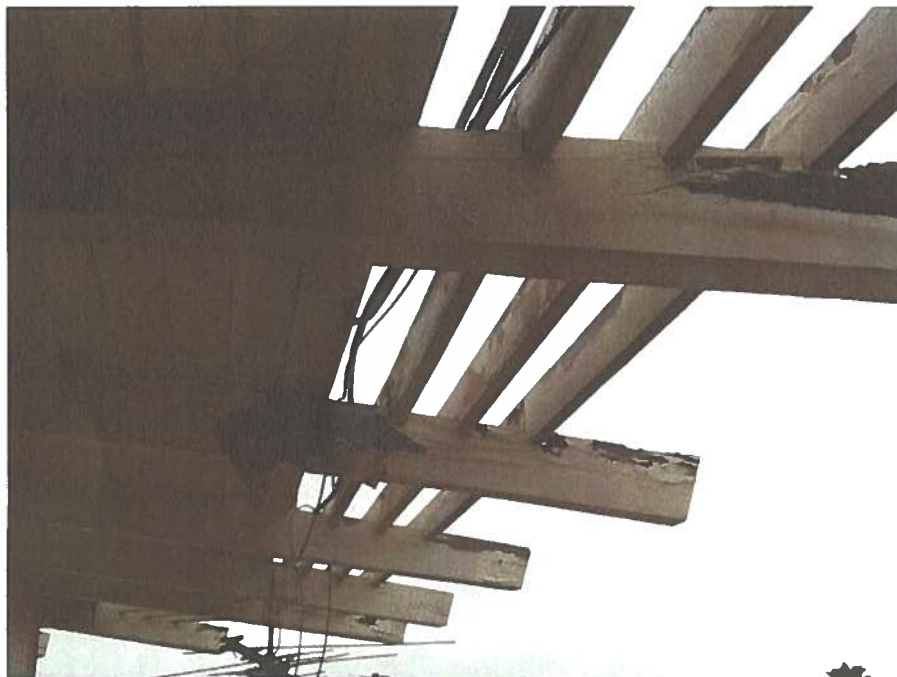
PHOTO #7

(E) 2x TRELLIS AT (E) HIGH ROOF

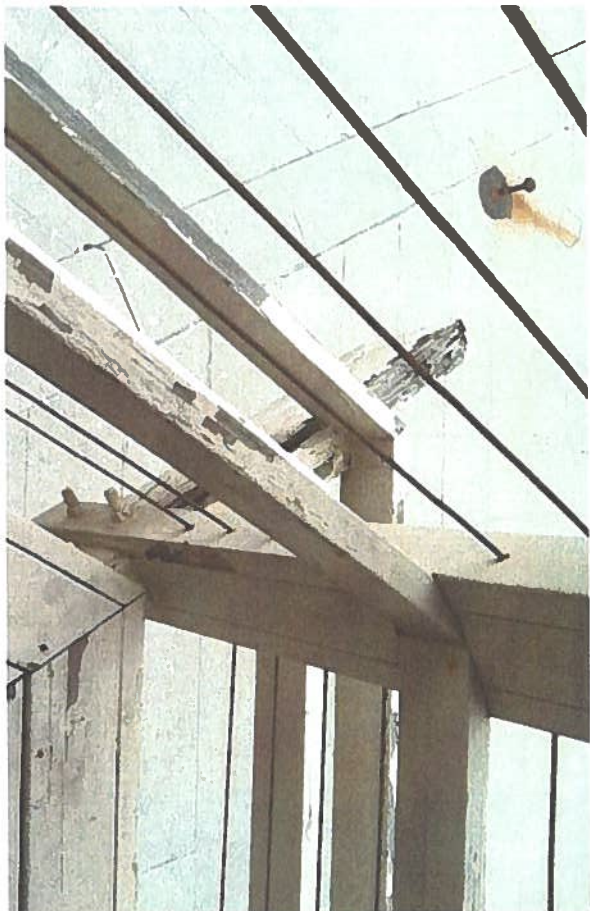
PHOTO #8

(E) 4X BEAM AT CORNER OF OBSERVATION LEVEL

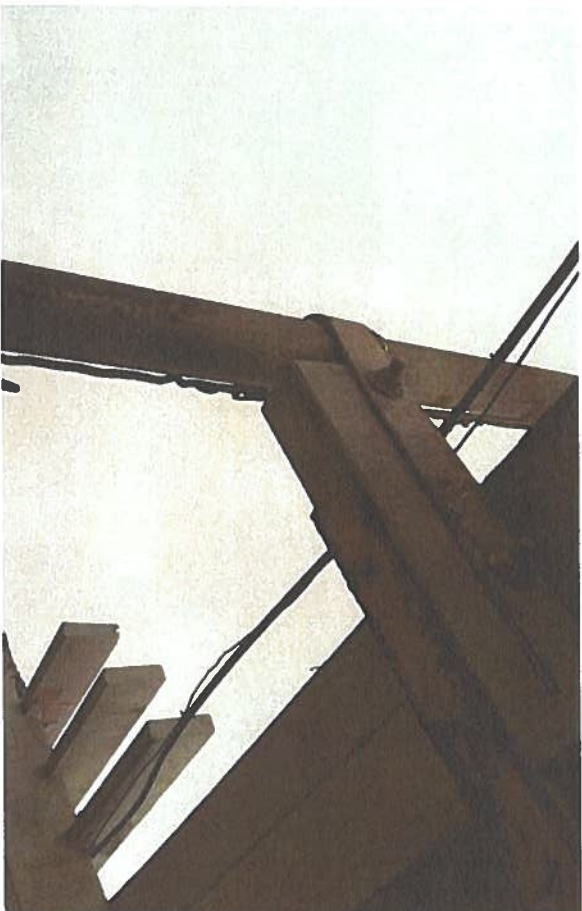
PHOTO #10

(E) STEEL POLE CONNECTION

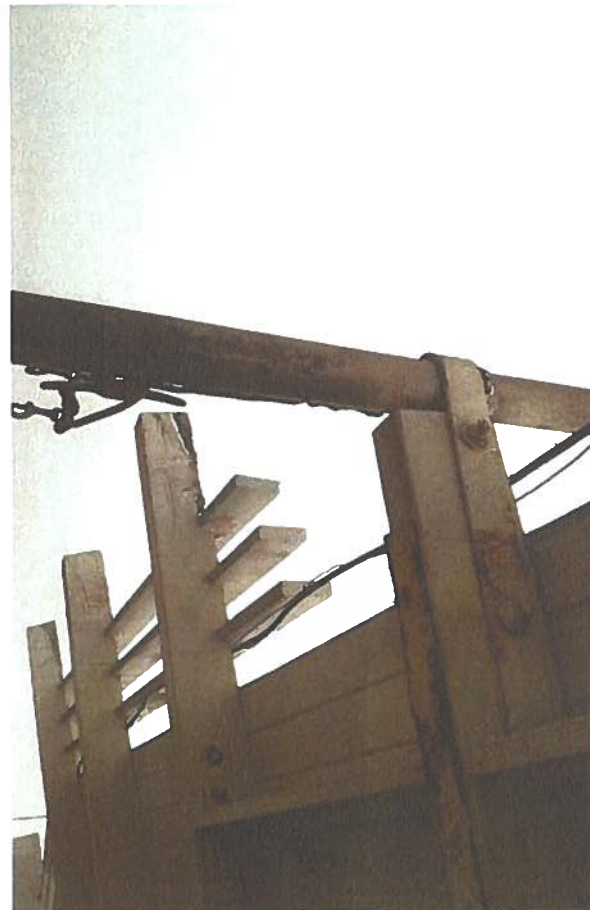
PHOTO #9

(E) STEEL POLE CONNECTION TO HIGH ROOF JOIST IN THE BACK

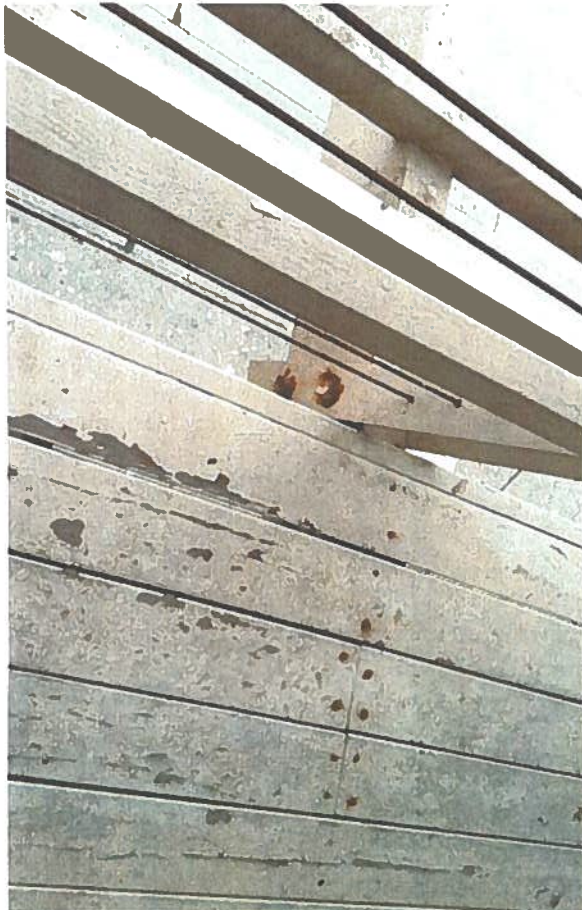
PHOTO #11

(E) 2X6 STRAIGHT T&G AT STEEL POLE

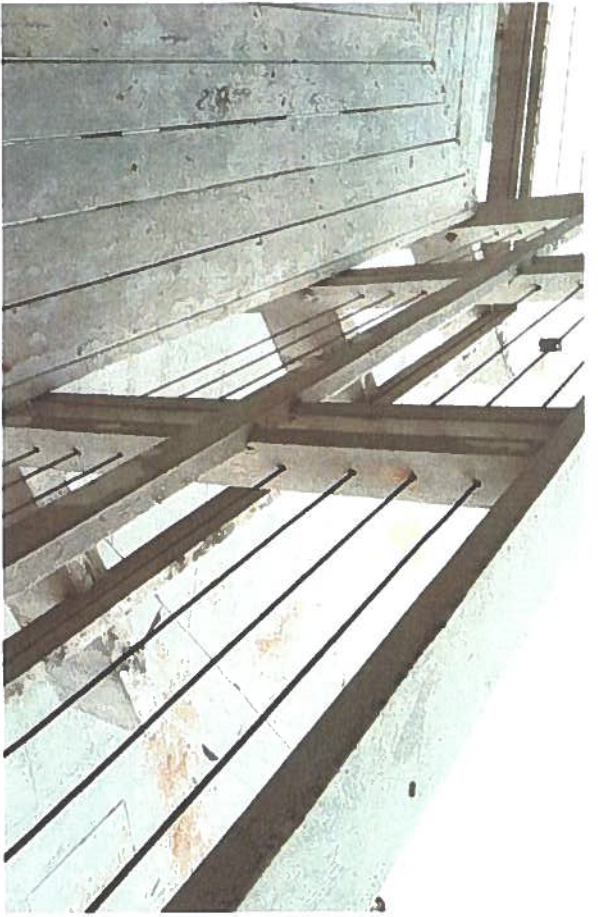
PHOTO #12

(E) 2X6 TRUSS AND (E) 2-2X BRACING AT OBSERVATION LEVEL )

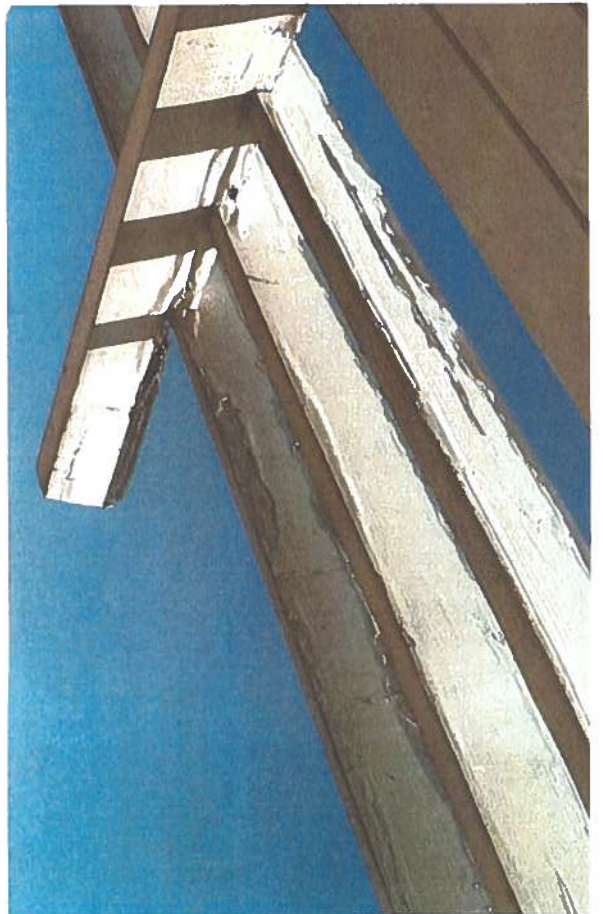
PHOTO #13

(E) 2X TRUSS AT HIGH ROOF, AND (E) 4X BEAM)

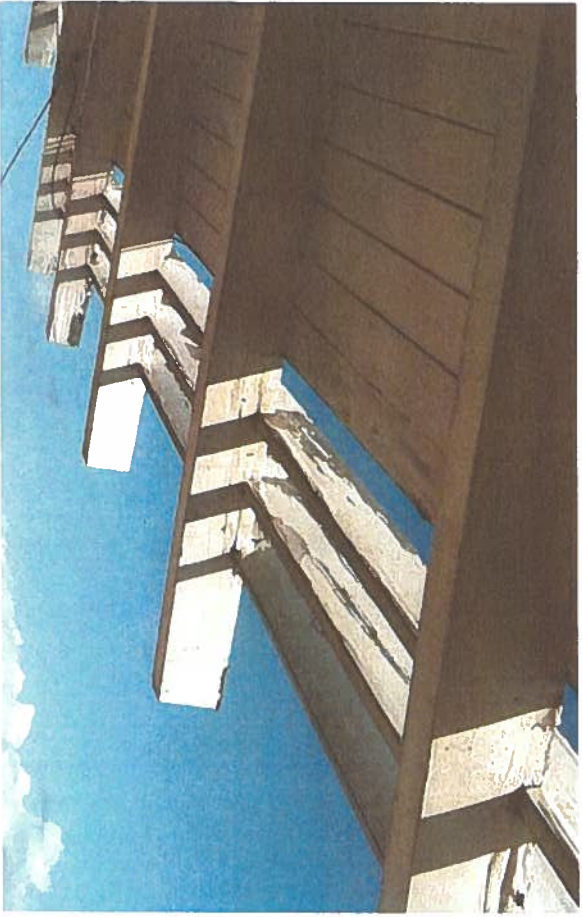
PHOTO #14

(E) 4X BEAMS AND (E) 1X6 TRUSS

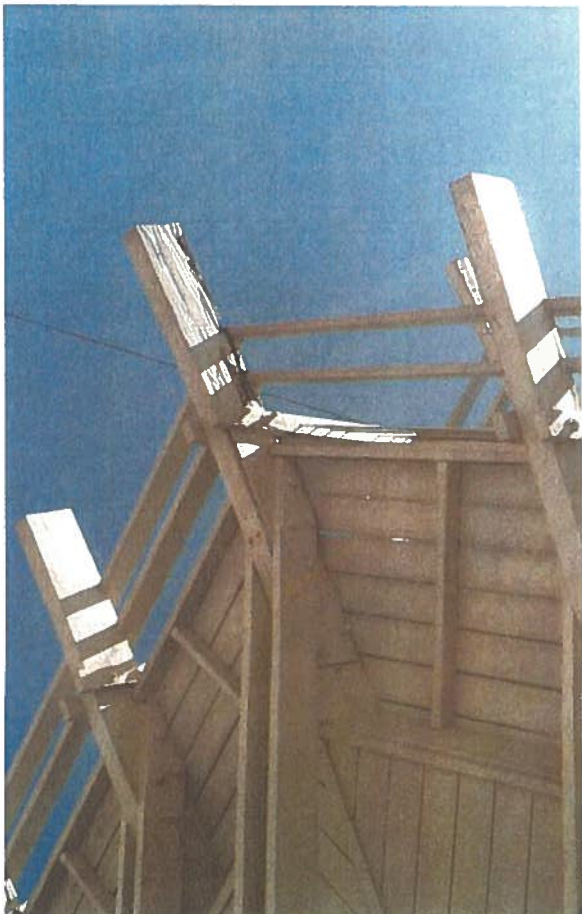
PHOTO #15

(E) 4X BEAMS, 2-2X BRACINGS, 2X6 TRUSS AND (E) 1X6 TRUSS

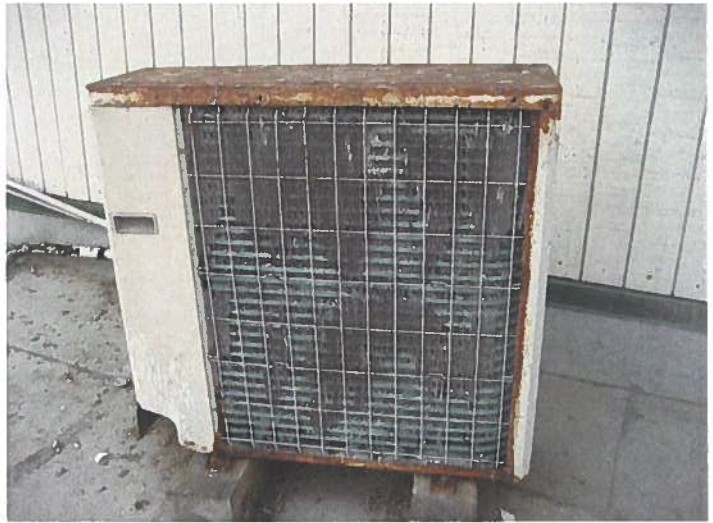
Four heat pump split systems were installed for the observation level approximately 10 - 15 years ago. These systems are currently not fully functional. All of the outdoor equipment and piping has corroded due to the harsh climate conditions. Indoor units are wall mounted type with exposed piping.

Existing outdoor heat pump

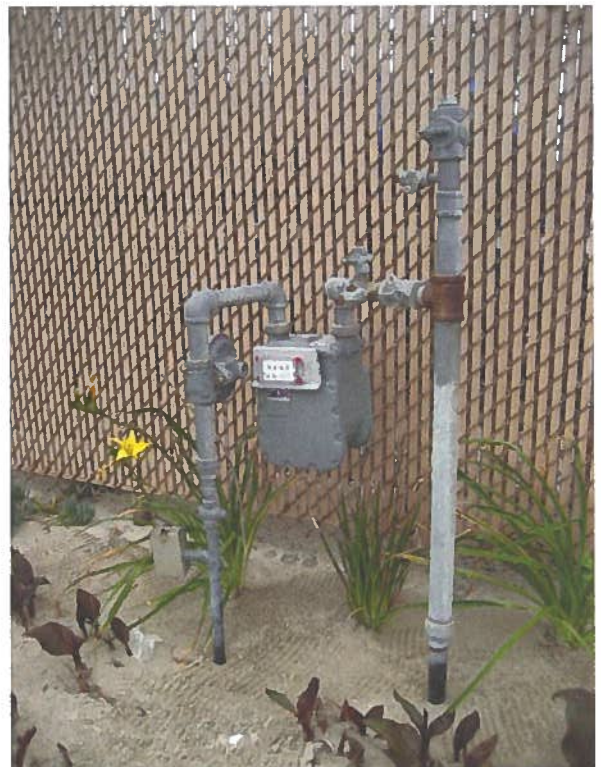
Existing gas meter missing seismic shut off valve

- a. Install backflow preventer on the domestic water system.
- b. Install natural gas seismic shut off valve at gas meter.
- c. Replace existing fuel alarms and controls.
- d. Replace all corroded fire sprinkler piping inside the building.
- e. Domestic hot water system should be analyzed further to confirm if the system provides heating hot water as well. Install the appropriate mixing valves as required by the CPC.
- f. Anchor oxygen bottles per NFPA requirements.
- g. Provide oxygen manifold, valves and alarms per NFPA requirements.

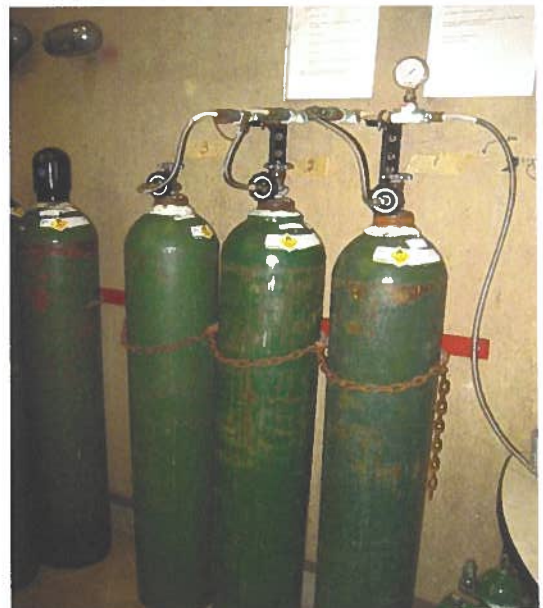
Part of the storage area is houses oxygen bottles for refilling the smaller portable oxygen bottles used by the staff. These bottles are only anchored at the upper third of the tank, and are missing the appropriate header, valves, and alarms required by NFPA.

Existing oxygen bottle storage area

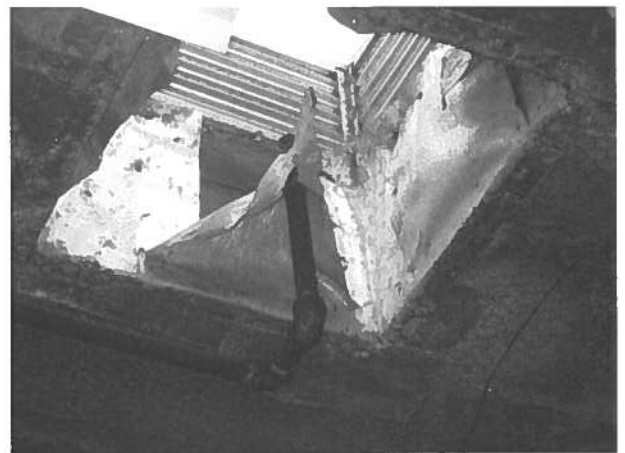
The fire sprinkler piping inside the garage is severely corroded in some areas and missing seismic bracing.

Existing fire sprinkler piping inside garage area
